EVALUATION AND ANALYSIS OF MATERIALS FOR REPAIRS OF POTHOLES: a case study of Calabar Metropolis

Article · September 2016

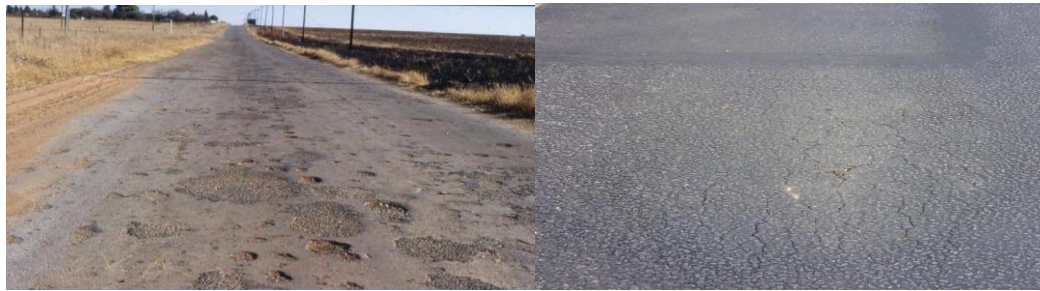
Fig 2. Development of potholes and fatigue cracking on a low-volume road with thin bituminous surfacing and insufficient preventative maintenance

Potholes are the form of a disintegration of the pavement that might be associated with inadequately compressed material, ravelling, cracking, base failure or aging of the pavement.

Accordingly, [1, 4], observed that potholes often appear after rain or during flow periods when pavements are weaker.

If water infiltrates the surface layers of the asphalt, it softening the underlying pavement layers, which increases deflections and the fines aggregates from the underlying pavement layers are lost, reducing overall structural strength and support for the pavement surface.

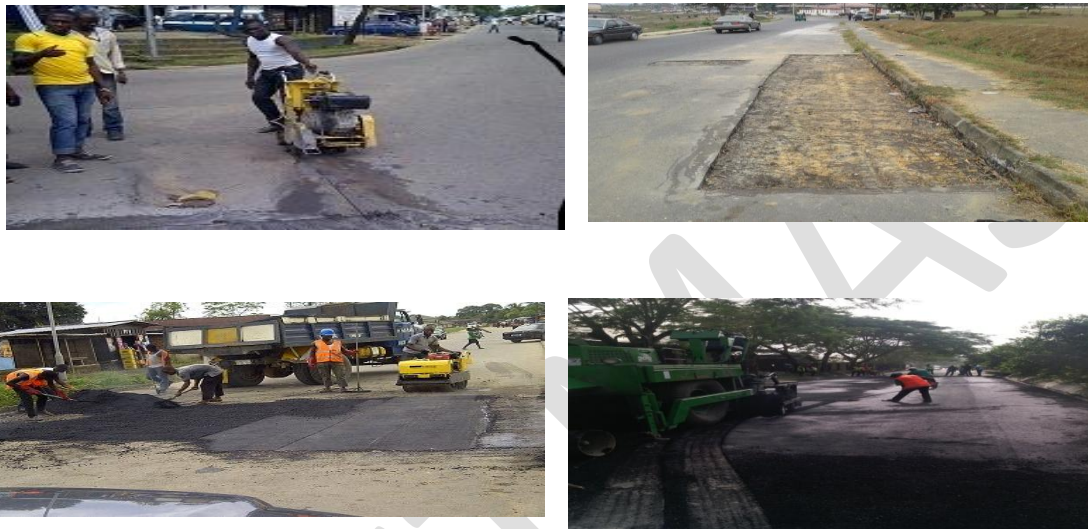
Fig.3 Cutting and patching of affected road pavement

The affected road pavement area is habitually cut to a regular shape with an asphaltic cutting machine. Usually, an offset of 15cm is used in getting a proper shape as shown in figure 3 below. The boundaries of the distressed area are marked. The repair edges are usually as square as imaginable and take into consideration the dimensions of the equipment that will be utilised for the replacement of the old material and compaction of the new material.

The affected pavement sides of the hole are square up, to provide sound pavement. This method is frequent, and incredibly very ease if the edges of the patch area were cut with a diamond saw or stabilised with cold milling equipment, [6]. It is only required when manual techniques of material removal are employed. It is recommended that the depth of the patch be 50% thicker than the thickness of the failed layer [6].

Apply a tack coat of asphalt emulsion to the sides and bottom of the hole at a rate of approximately 1 litre/m² of slow or rapid setting emulsion. The tack coat should either be sprayed or brushed on the edges of the repair, never poured.

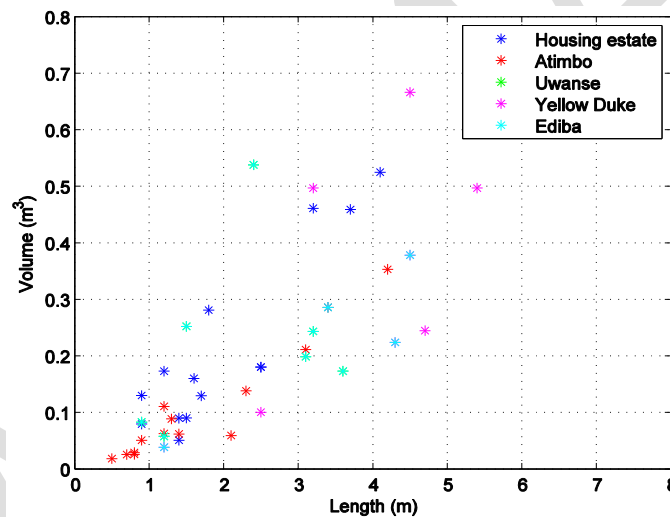
Fig. 4 illustrate scatter plot of potholes measurement of Calabar Metropolis

Five different areas within Calabar Metropolis were selected a potholes measurement were carried out in the five areas. Namely, Housing Estate, Atimbo, Uwanse, Yellow Duke and Ediba Road and potholes scatter graph were plotted as shown in figure 5. The estimated total volume of asphalt used for patching of Yellow Duke Road and Ediba Road were approximately 3.7 to 3.9 m³ compared to others locations. It was observed that the volume of asphalt used in the patching of potholes in Ediba road was high compared to others location as shown in Table 5. Due to the nature of the existing drainage system and culvert in this location which is usually found to be silted and then carrying runoff water to the road which destabilises the subgrade and base course which results in wearing away the asphaltic surface and also permits potholes on the road. However, Periodic Maintenance should be carried out to covers activities on a section of the road at regular and relatively long intervals, which must be aimed at preserving the structural integrity of the road and these operations tend to be large scale, requiring specialised equipment and skilled personnel. The periodic maintenance is very profitable compared to routine maintenance work which required accurate identification and planning for implementation, and the design activities can be classified as preventive resurfacing, overly and pavement reconstruction. This involved resealing and overlay works that are initiated in response to steady deterioration in road conditions.
